# SAFETY BULLETIN

## MILITARY SEALIFT COMMAND

## Line Handling Incident

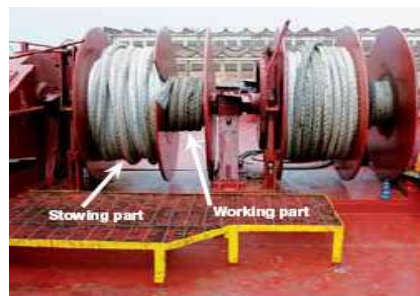
During the shift forward the Master noted that one of the forward spring lines was taut and ordered it slackened. The line was not slackened and suddenly went slack.

A short time later the crewmember operating this winch was found lying on the deck next to the winch platform. He had a severe head injury and his safety helmet was split in half. None of

The investigation determined that the third mate could not adequately supervise the operation of tending four lines with four men (boatswain, fitter, and 2 ABs )

The second spring line added unnecessary complexity to the forecastle operations. A lack of preparedness and communication

operation starting before the crew on the forecastle were ready.

- The third mate's position during the shift ship operation meant that he did not have a clear view of the spring lines or the crew members operating the spring winch.

conditions would have resulted in high speed recoil, as the energy in the mooring line was released. The winch drum would have started to rotate and then accelerate rapidly. For a time the winch drum would have spun faster than the speed at which the mooring line could run out. This action may have led to the formation of slack turns or loops of mooring line which would have been rotating with the drum. It was
